Bakun Dam ‘Unsafe’! – Exclusive Evidence on Corner-Cutting and Sloppy Construction Practices

Posted Wednesday, April 13th, 2011

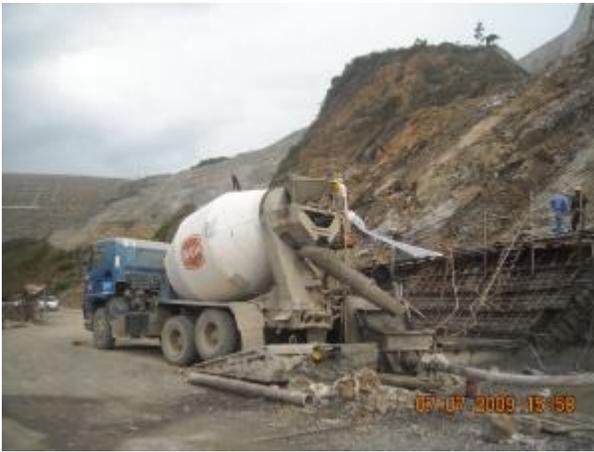
Watering down the concrete! Construction phase in 2009.

The sensational video footage [below] clearly shows workers hosing extra water into the cement mixers before it is pumped into the dam, which is visible in the background. Our information is that this forbidden practice was endemic on the project and that poor quality control procedures allowed it to happen.

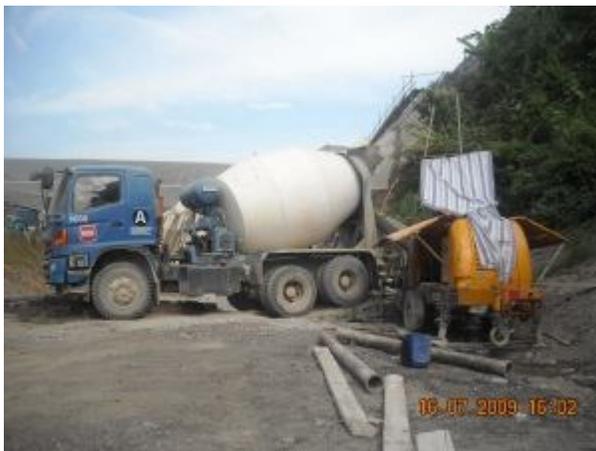
At it again. Our informant says this is another occasion when he caught workers watering down the concrete, but that his bosses did not take it seriously.
